Final Report

Siler City Stormwater Infrastructure Mapping and Assessment Project

June 2020

Prepared by the
Triangle J Council of Governments
in partnership with
Biocenosis, LLC

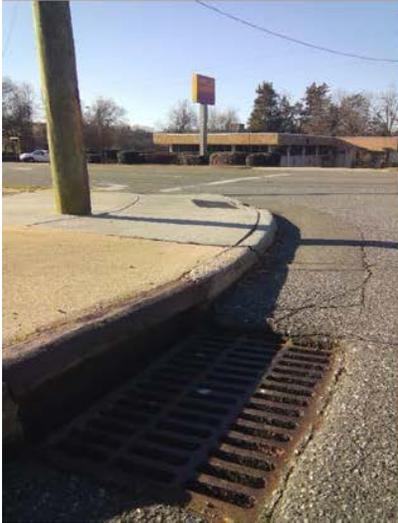
Clear catch basin

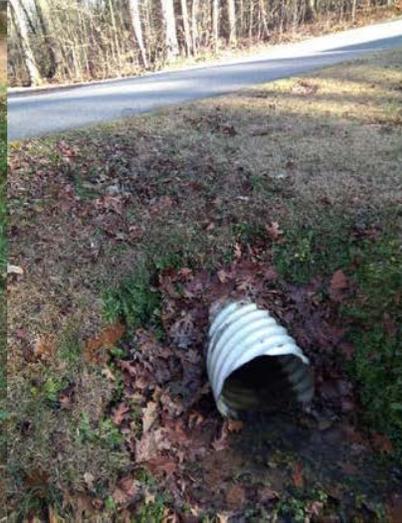
Clear culvert

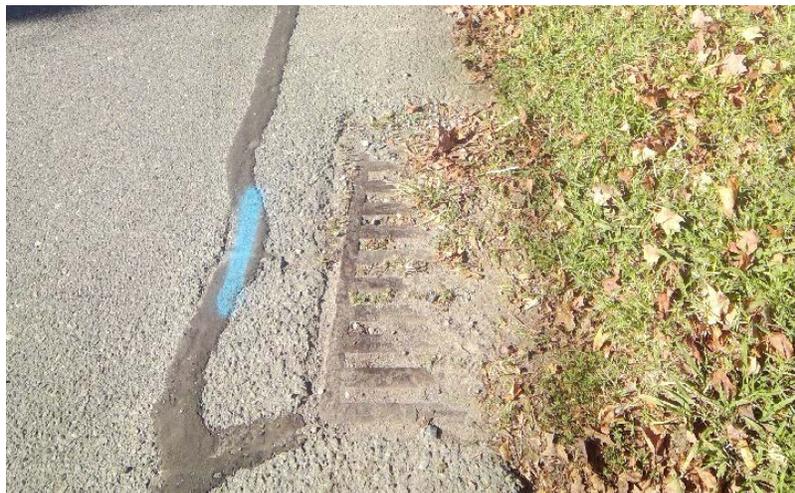
Figure 10: Catch Basin Full of Sediment (Cleaned 5/2020)

Based on preliminary results that TJCOG and Biocenosis shared with Siler City staff at a May meeting, Siler City staff cleaned out the following infrastructure features:

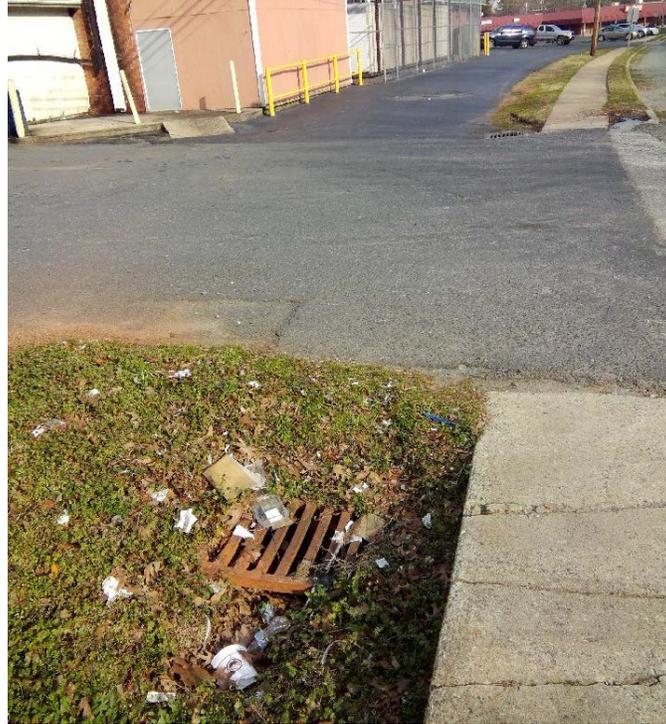
Figure 12 below shows how stormwater has picked up litter and dropped it a low-lying storm drain (here, outside the Piggly Wiggly on West Raleigh St.) after which it will be washed into the creek.

Figure 13: Litter in Catch Basin Outside Piggly Wiggly

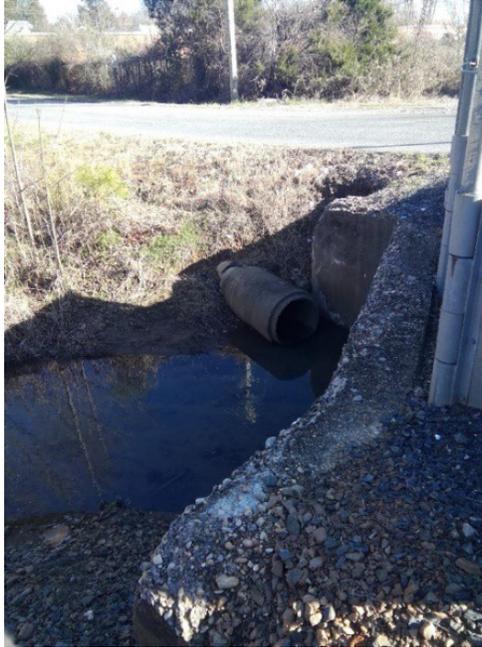
Figure 16: Outfall Pipe with Oil Sheen
