Final Report

Siler City Stormwater Infrastructure Mapping and Assessment Project

June 2020

Prepared by the
Triangle J Council of Governments
in partnership with
Biocenosis, LLC

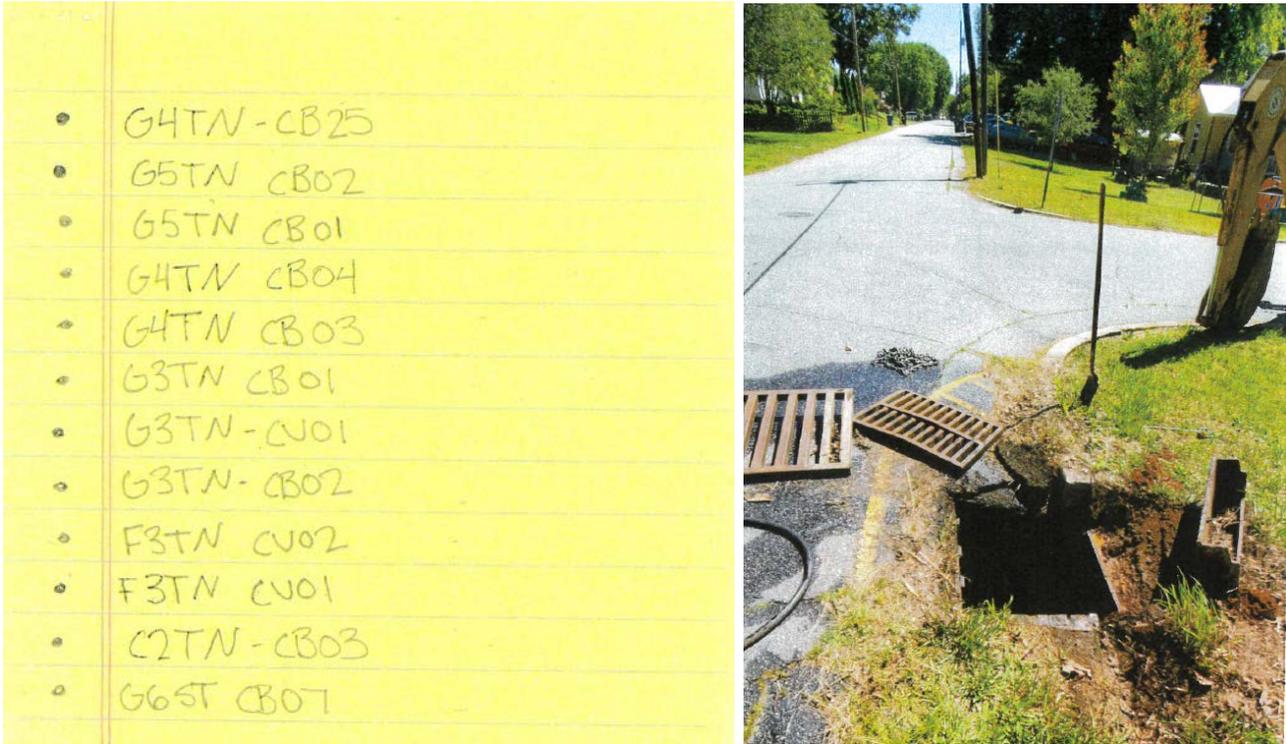
Figure 9: Stormwater Infrastructure Cleaned Out May 2020

Based on preliminary results that TJCOG and Biocenosis shared with Siler City staff at a May meeting, Siler City staff cleaned out the following infrastructure features:

The infrastructure cleaned out in May 2020 has been noted in all map formats while remaining in the “cleanout needed” field due to likelihood of these infrastructure features filling up again as they drain low-lying areas which receive large volumes of debris in stormwater runoff.

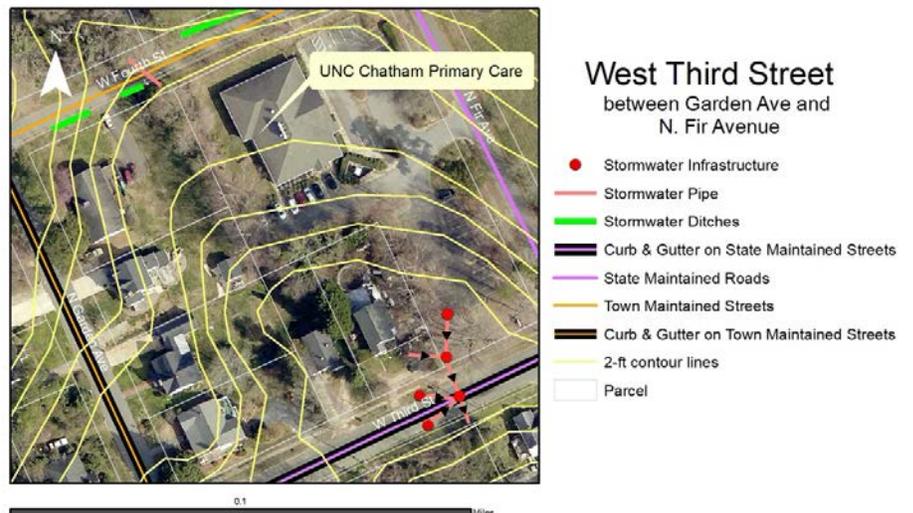
Stormwater runoff on W. Third Street

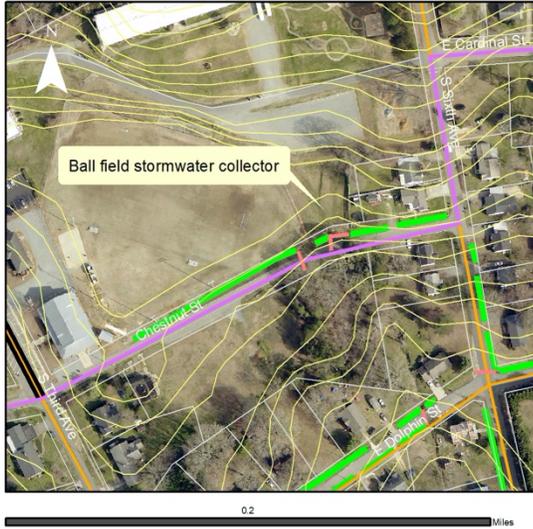
Paul Braxton Gym Ball Field Stormwater Collector (Grid G9)

A stormwater collection system east of the Paul Braxton Ball Field on Town property directs stormwater to the stormwater pipe that flows under Chestnut Street. The outflow system is broken and eroding. Potentially a SCM such as a Regenerative Stormwater Conveyance system could be installed to slow and reduce the flow.

Ball field Stormwater
